# An AMAZING Elastomeric Membrane Coating

# PRODUCT DESCRIPTION

# FIELD APPLICATION CASES SHOPPING CENTRE ROOF: 8000M2+

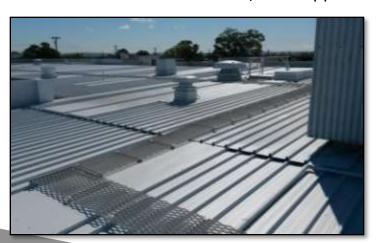
RTT Sealant brush/roller applied

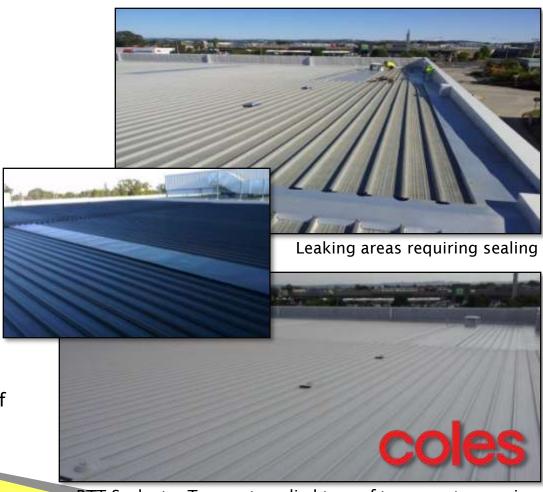
RTT Sealant + Top coat applied to roof to prevent corrosion

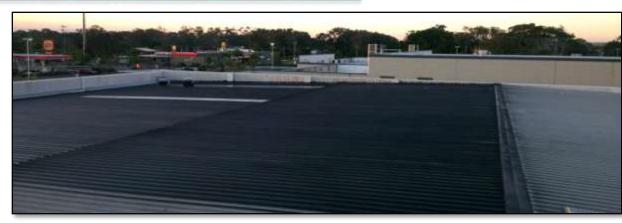
2. RTT Sealant applied to entire area

3. RTT Top Coat applied to RTT Sealant

1. RTT Sealant applied to joins and corners

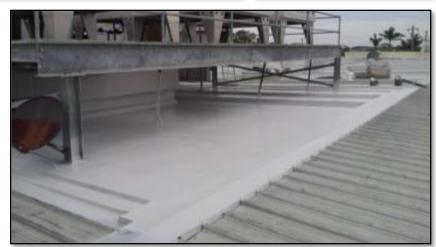
Leaking and corroded areas requiring sealing

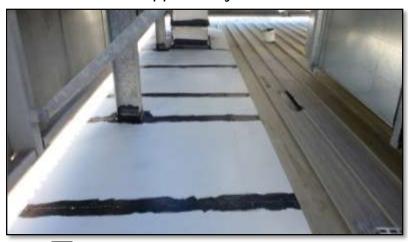
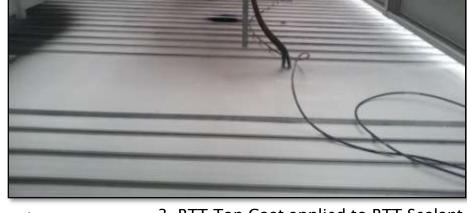
1. RTT Sealant applied to joins and corners

3. RTT Top Coat applied to RTT Sealant

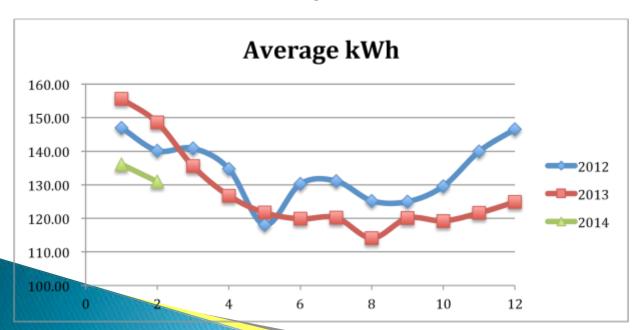
RTT Sealant were provided with the energy consumption data from January 2012 to February 2014. The calculations below indicate the reduction in energy consumption as a result of the application of the waterproofing membrane and solar top coat to the roof areas.

December 2012: **146.57kWh** December 2013: **124.86kWh**

Representing a 14.2% reduction in power usage

January 2013: 155.63kWh
January 2014: 136.11kWh

Representing a 12.5% reduction in power usage

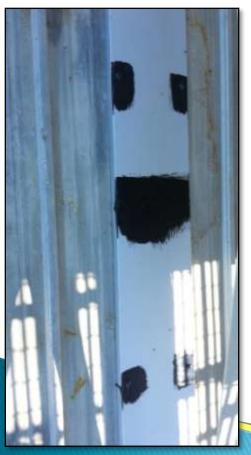
1. RTT Sealant applied to joins and bolt heads

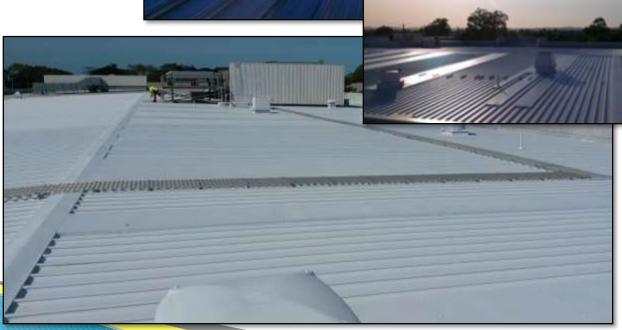
2. RTT Sealant applied to entire area

3. Solar Top Coat applied to RTT Sealant

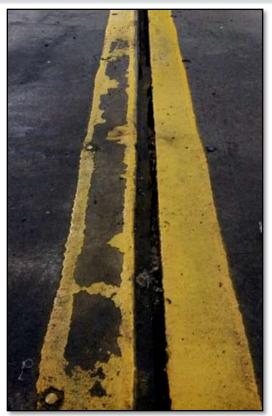
Existing joint sealant to be removed

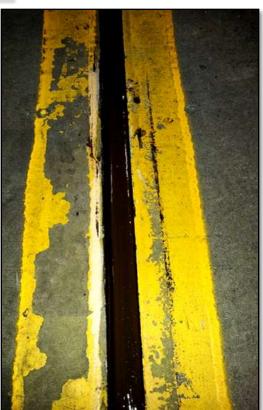
RTT Sealant poured in to seal and close joint
